# Navajo Abandoned Uranium Mine Site Screen Report

**Homestake Sapin No. 23**

**Navajo AUM Eastern Region**

**May 2009**

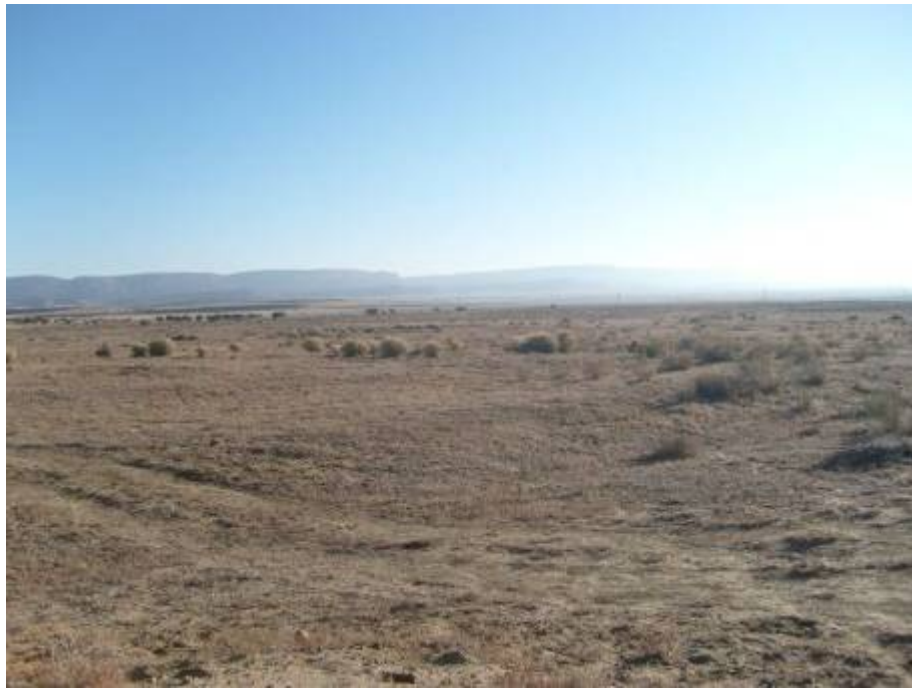
Photo 1. Homestake Sapin 23 mine site, towards the east/northeast

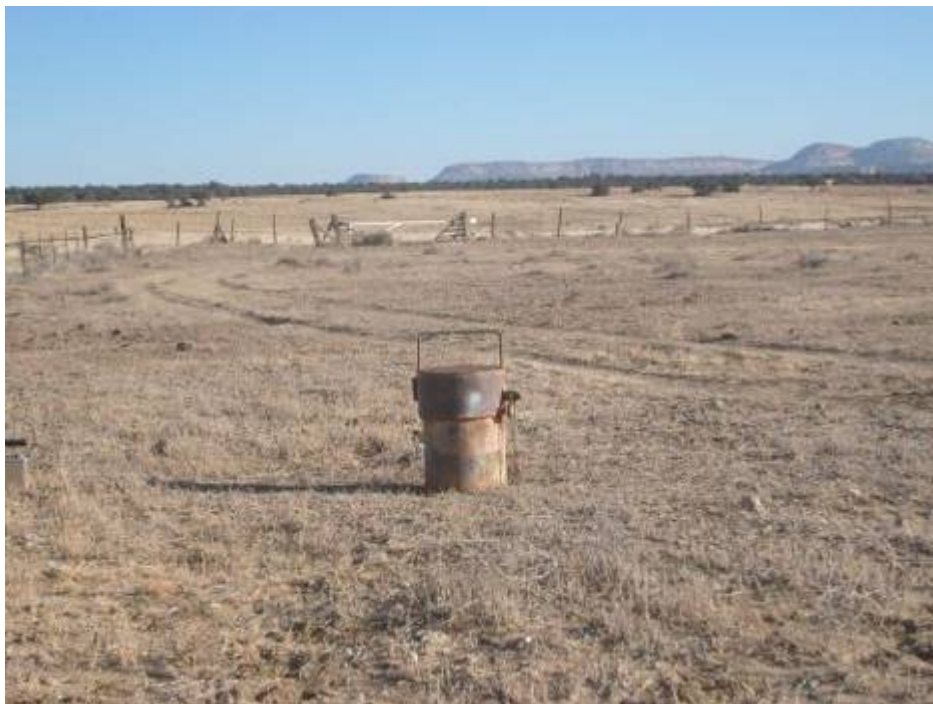
Photo 3. Well head with gate in background (entrance to Homestake Sapin 15), towards the north

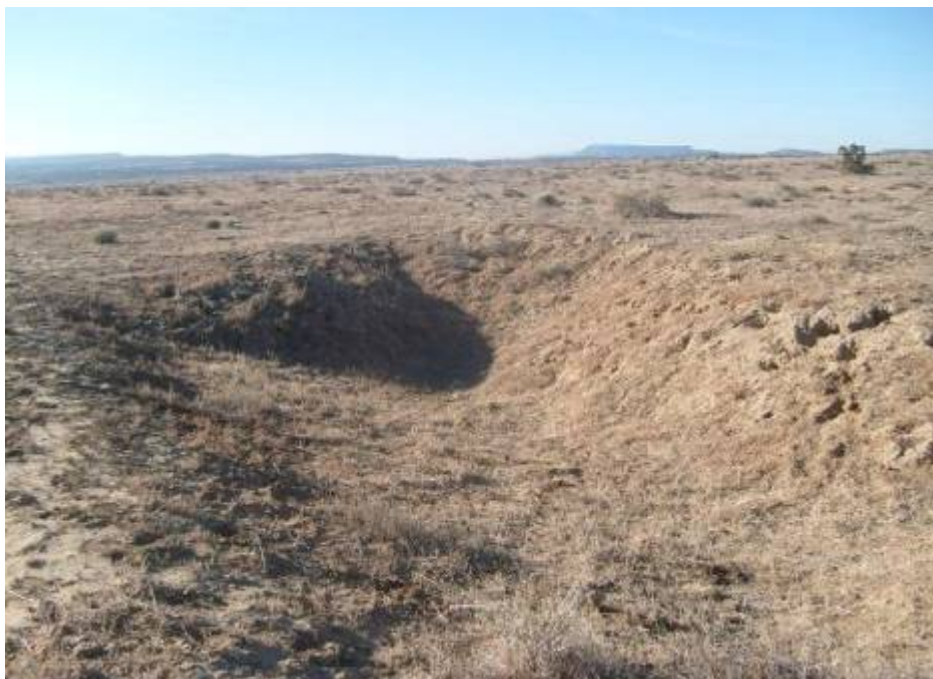
Depressions in the landscape were scattered throughout the site. Two of them were approximately 40'x 16'. The probable cause for these depressions is subsidence.

Photo 4. Depression where first background reading was taken. View looking south/southwest

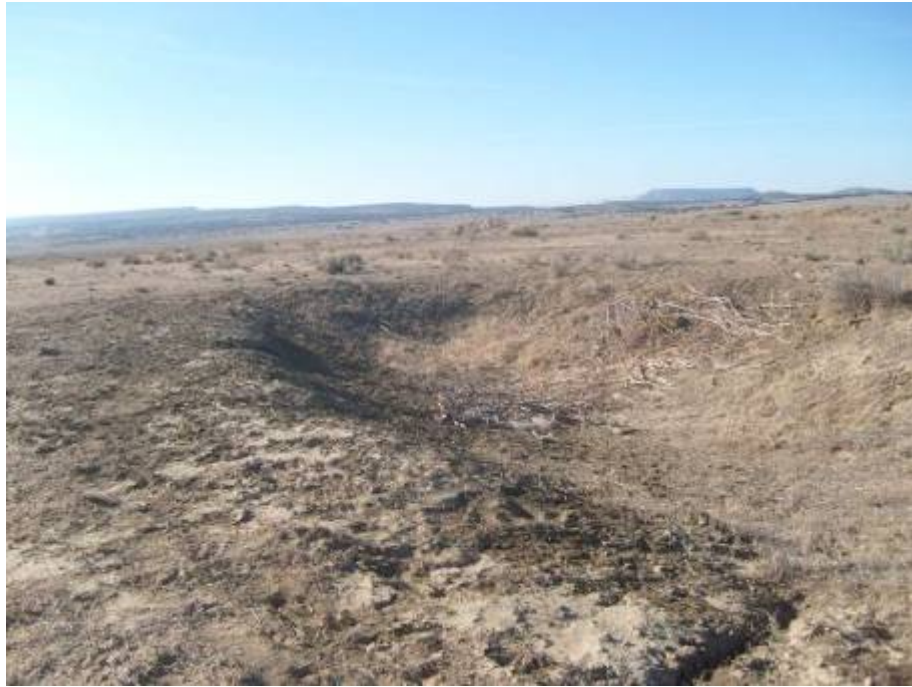
Photo 5. Depression approximately 100 yards northeast of car, towards the south/southwest

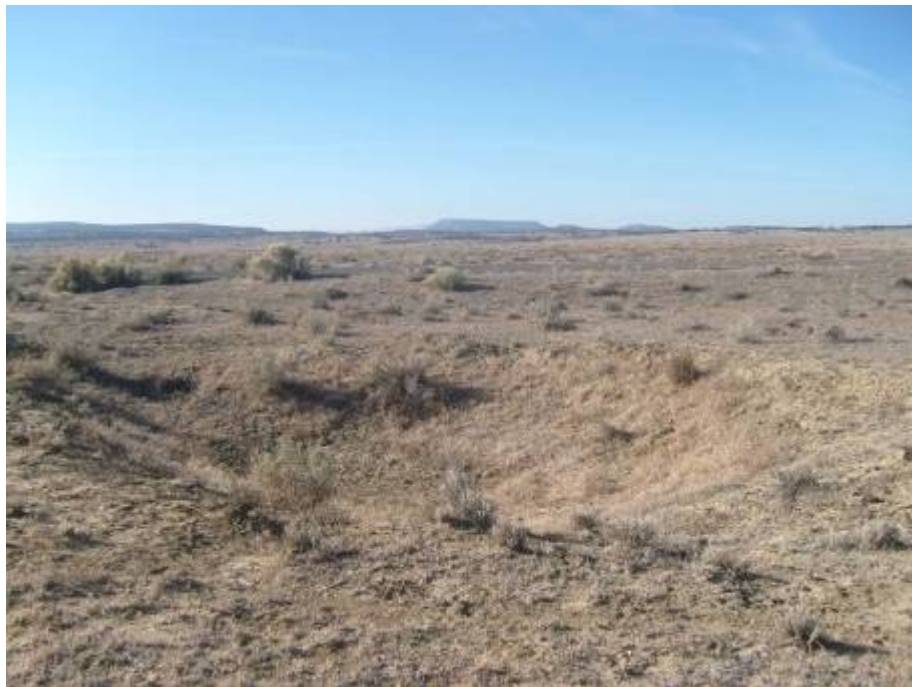
Photo 6. Depression looking south/southwest, with main road in background

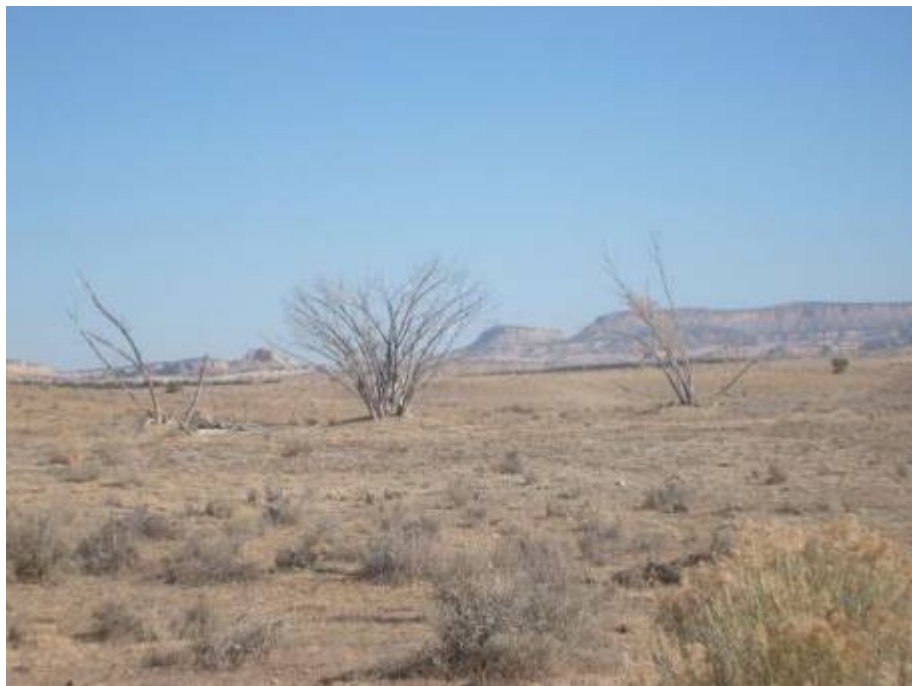
There were three dead trees east of the reclaimed waste pile (fenced in). Readings were approximately 120,000 counts per minute (cpm).

Photo 7. Dead trees east of waste pile, towards the north

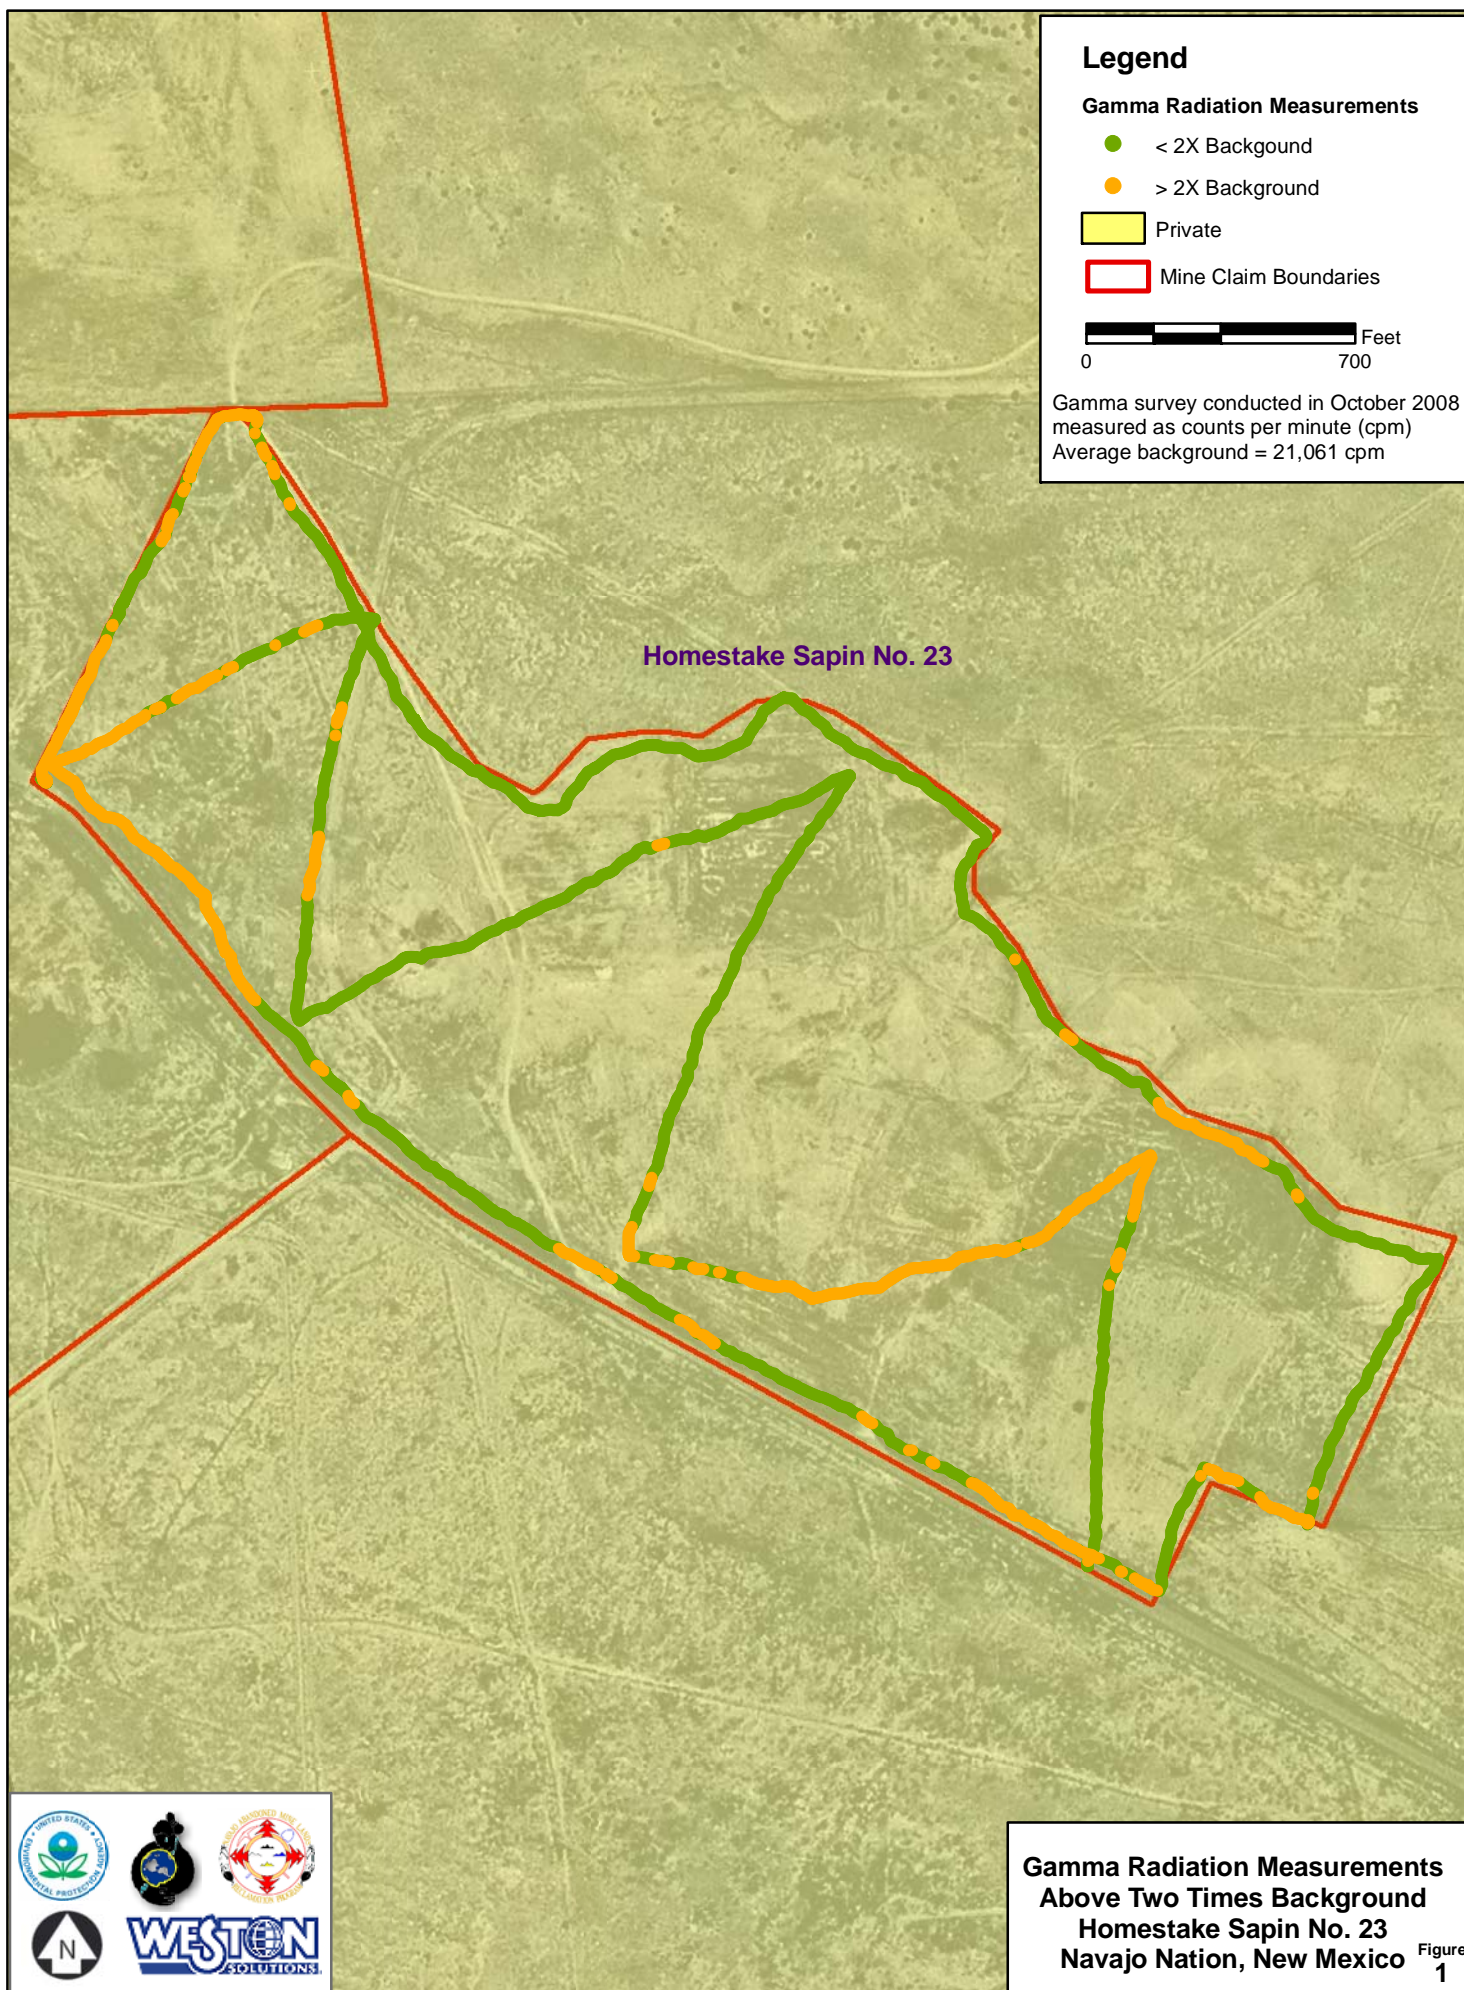
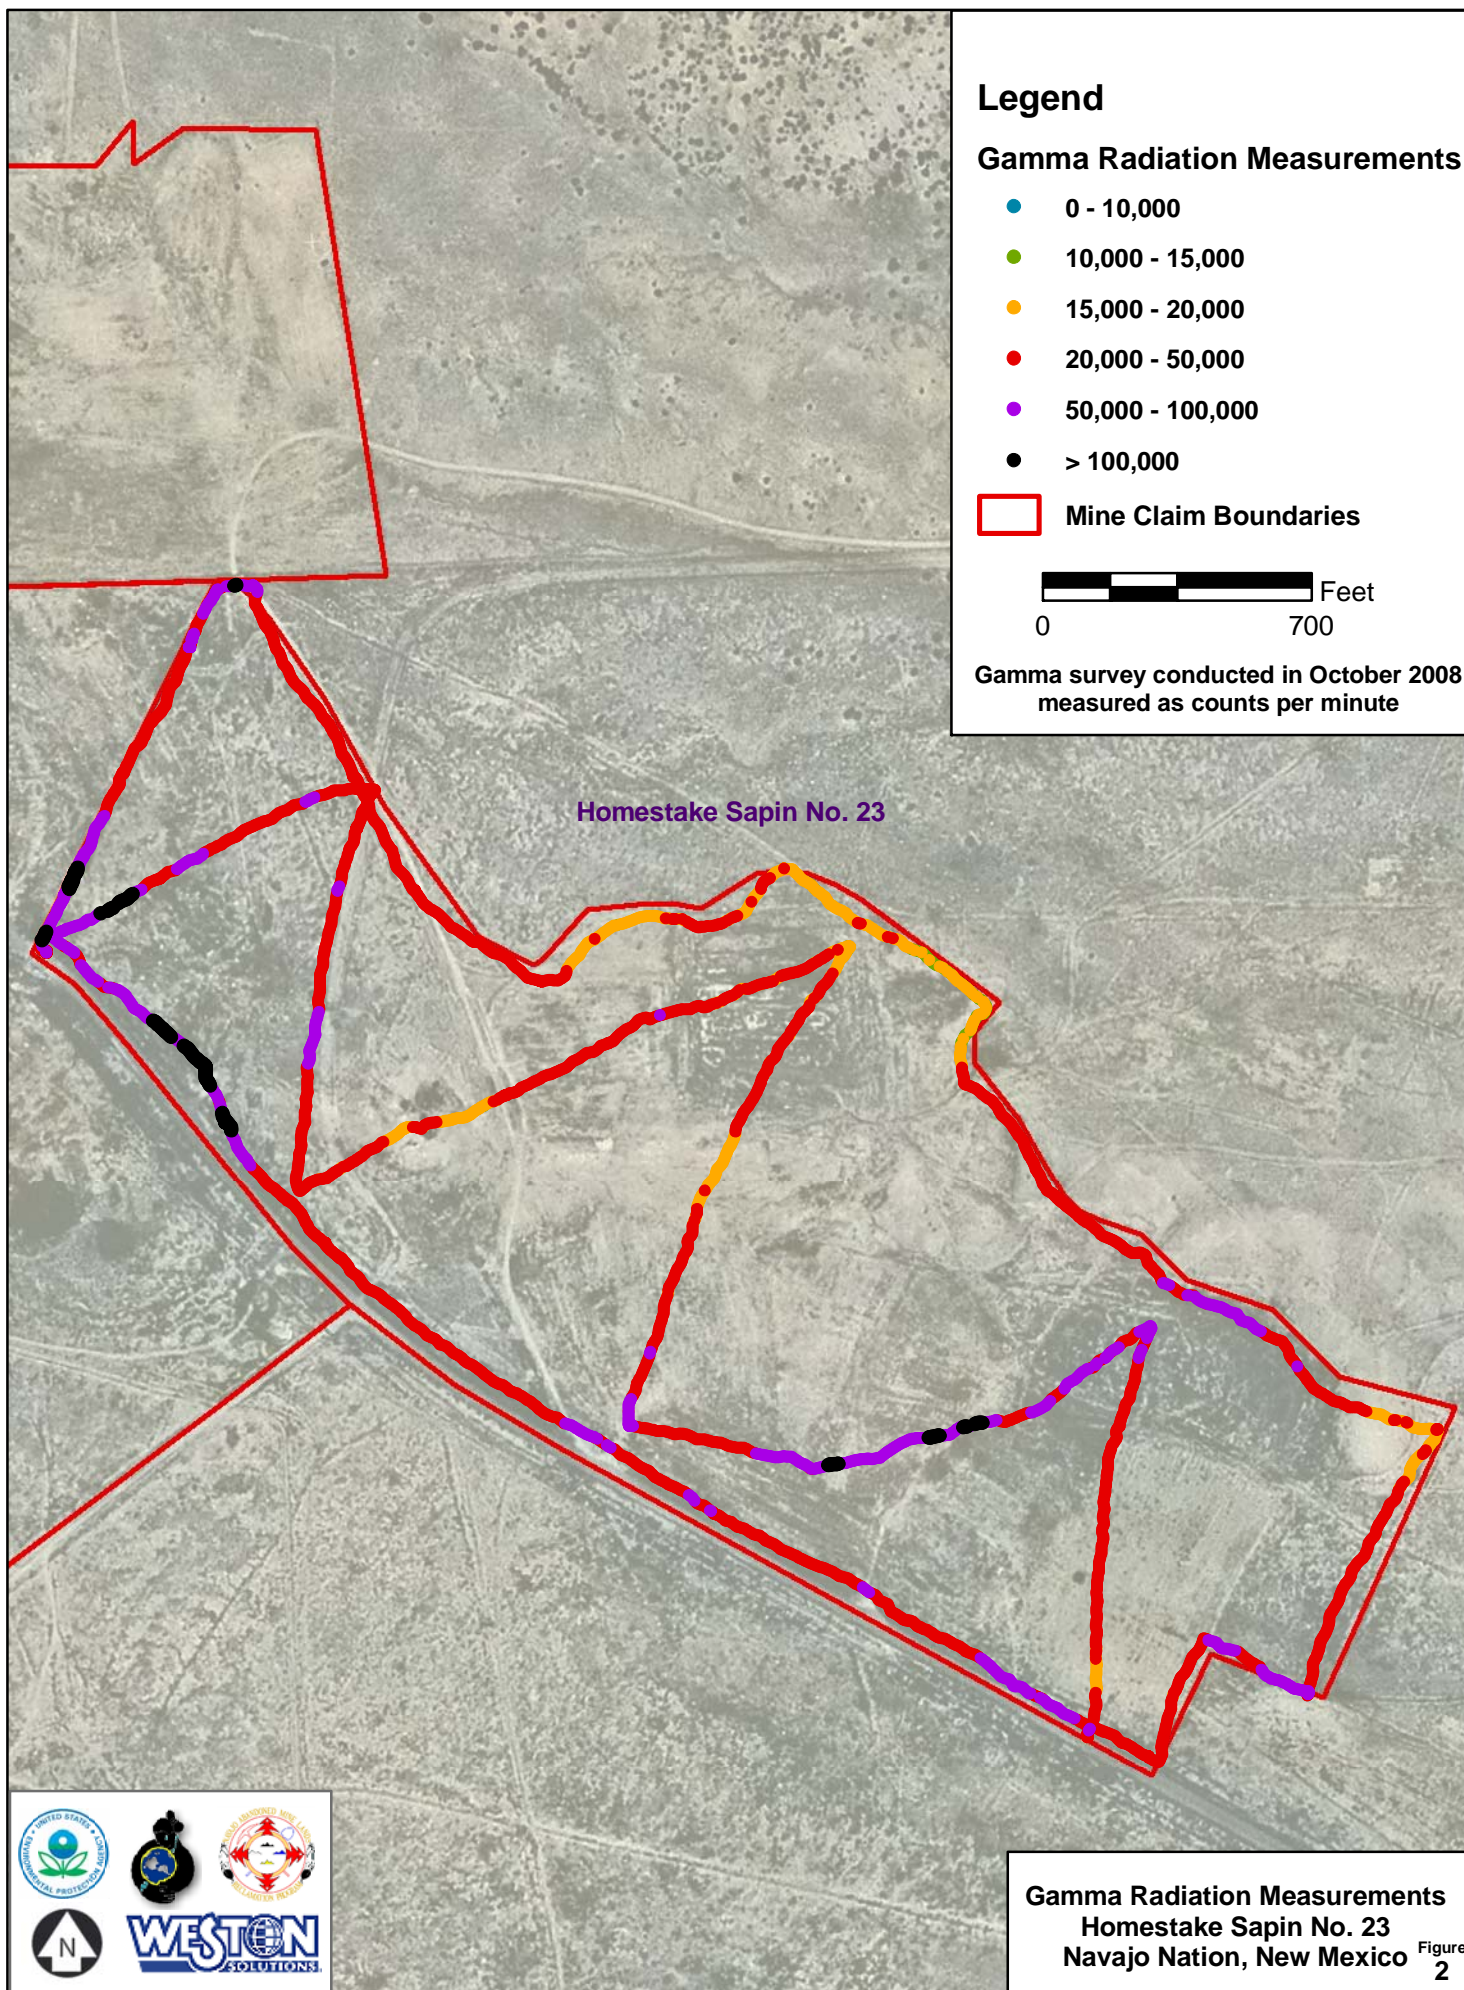
A total of 5,599 gamma radiation measurements were collected from the mine site, ranging from 12,297 cpm to 301,433 cpm. Reading on the well head was 48,317 cpm. The highest readings detected were primarily in the western part of the site, with the exception of the readings taken at the dead trees (120,000 cpm). The lowest readings recorded as background readings were taken in the depressions, and in a low-lying area (north of main road). The measurements are represented in Figures 1 and 2.
